Model: 377DAT – Customer Report: Keys and don't work Properly

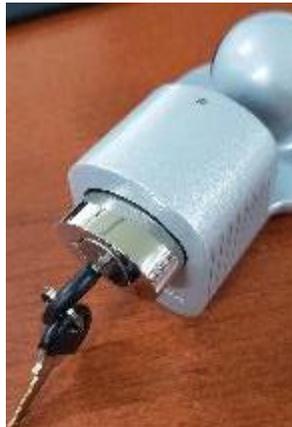
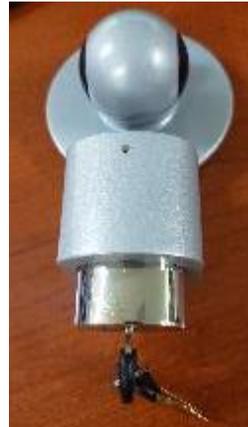
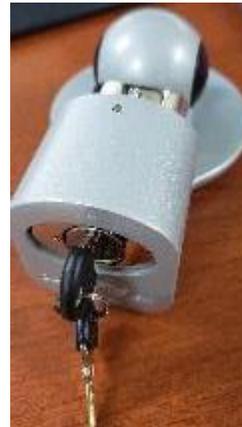
We have Inspected 3 sets of lock and we haven't found any anomalies, all lock open with their set of keys and no other issues were found
