Test Report

Report No.: SAC2024-02186013ER1

Sample Name : OpenSwim Pro
Sample quantity : 1pc
Model/P.O. No. : SHOKZ S710
Item/Lot No. : /
Material : /
Buyer : Shenzhen Shokz Co., Ltd.
Supplier : Shenzhen Shokz Co., Ltd.
Manufacturer : Shenzhen Shokz Co., Ltd.
Received Date : Jan. 29, 2024
Test Period : Feb. 22, 2024 ~ Feb. 23, 2024
Test Requested : According to customer requirements, perform the IPX8 waterproof test.

Serial number	Test Item(s)
1	IPX8

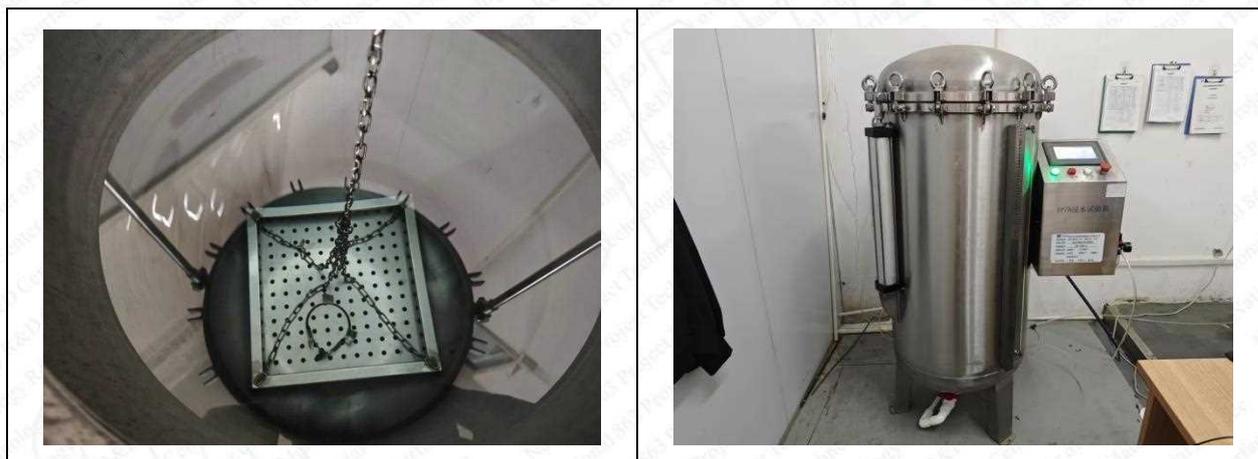
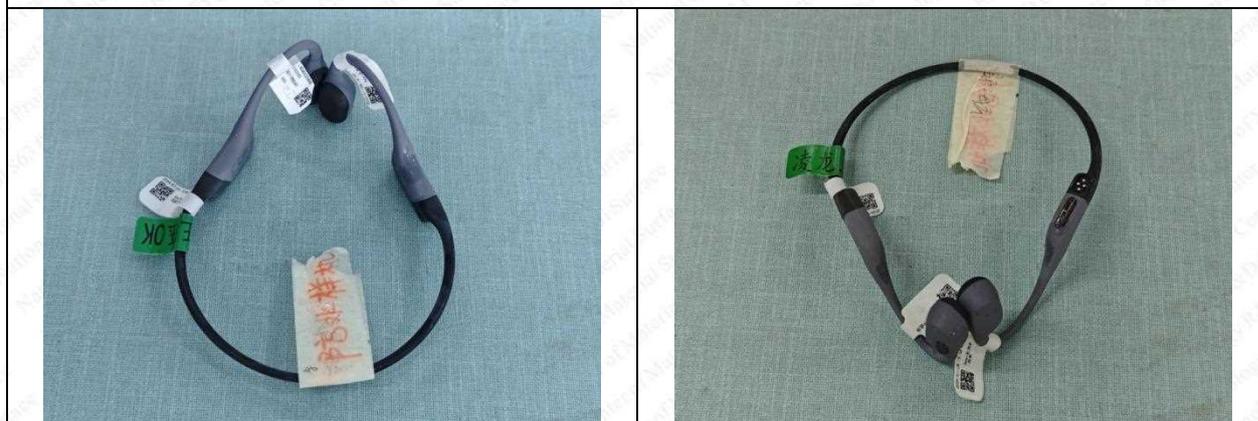
Fig.2 During the test

Immerse the sample into the water-proof test equipment that simulates the water depth of 2m (or the pressure condition equivalent to 2m, but the product must be submerged by water) .After 2h, take out the

Sample No.	Test Result(s)	Conclusion
1#	After the test, the sample function check is OK; There is no trace of water intake in the left and right warehouse body and horn shell.	PASS

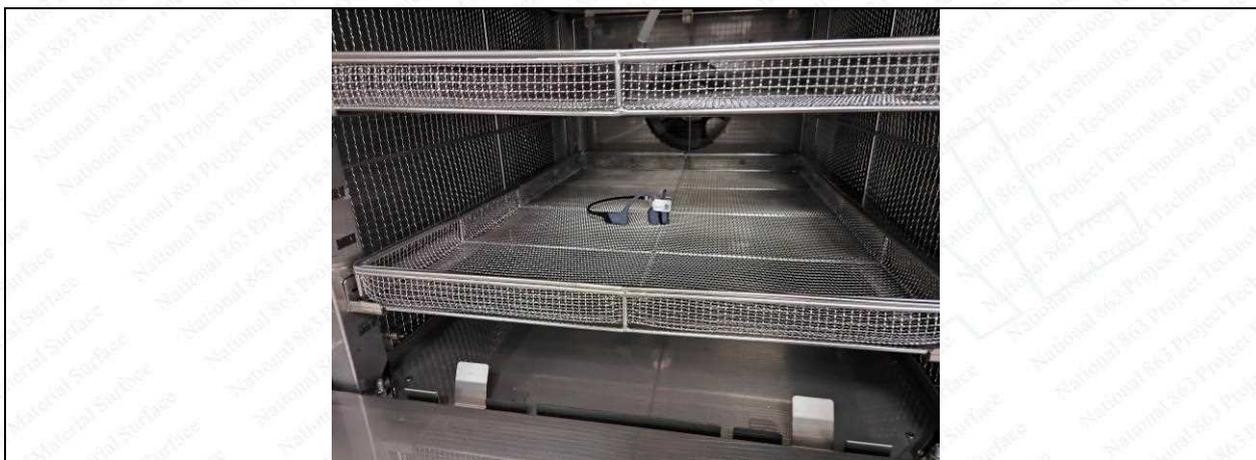
Fig.2 During the test

T1: -30°C, T2: 65°C; Test duration: 1 h at each point; Transfer time: ≤ 3min; 12 cycles.

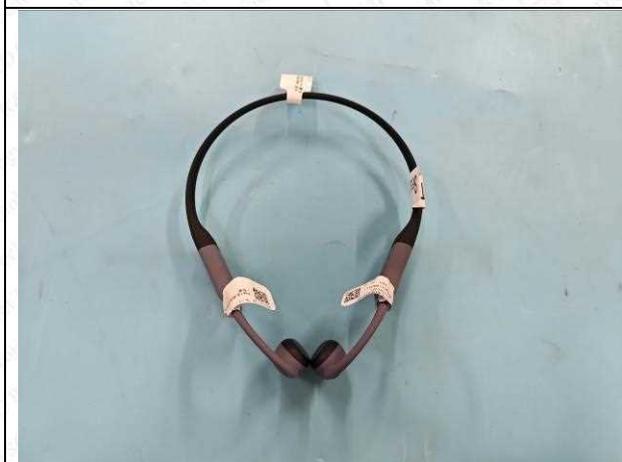
Fig.3 After test sample photos

Sample No.	Test Result(s)	Conclusion
6#	After the test, the function of the sample is normal. There are no obvious changes on the appearance, no tackless or rupture.	PASS

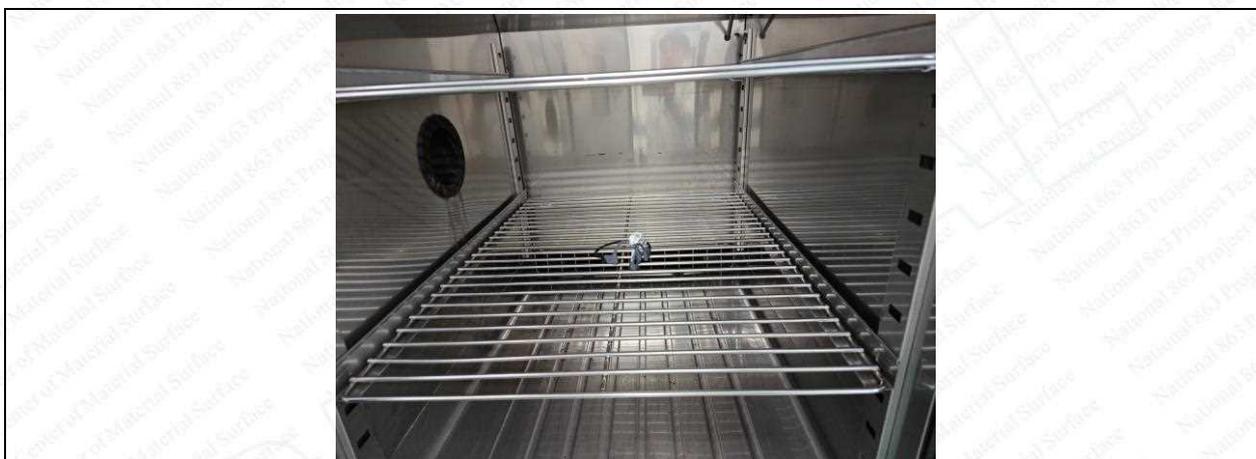
Fig.2 During the test

Test condition: 55°C, 95%RH for 96h; ;

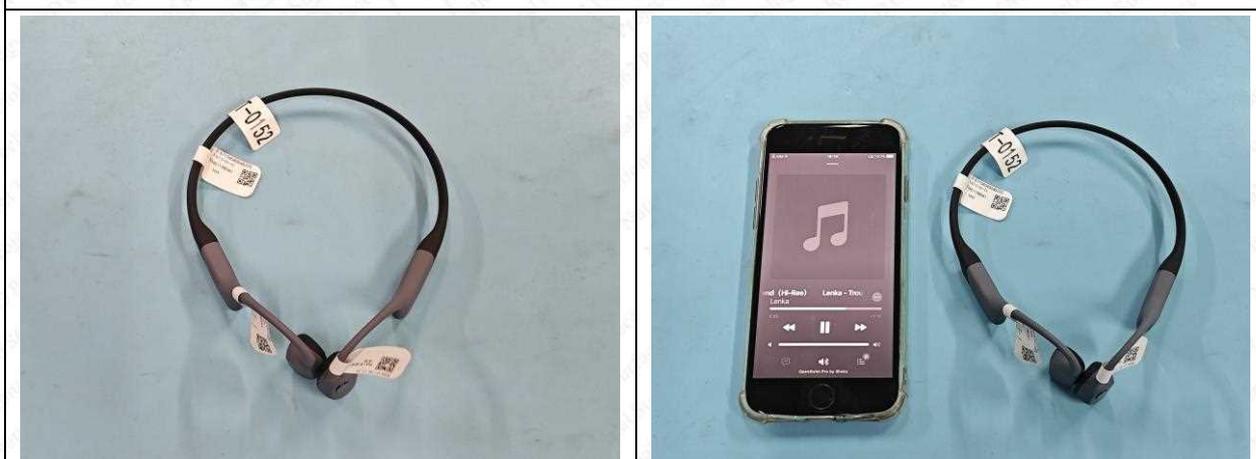
Fig.3 After test sample photos

Sample No.	Test Result(s)	Conclusion
7#	After the test, the function of the sample is normal. The battery did not catch fire or explode; There are no obvious changes on the appearance, no tackless or rupture.	PASS

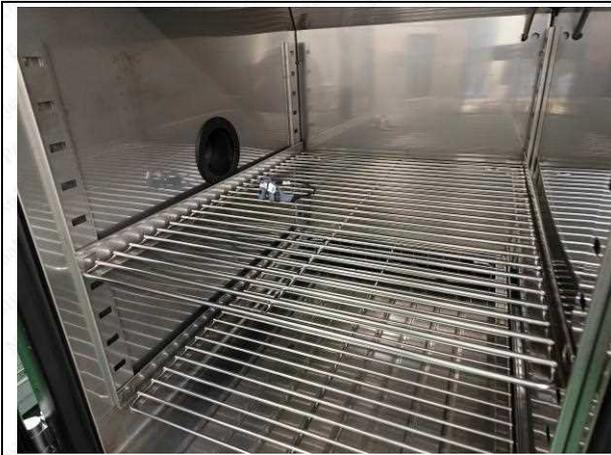
Fig.2 During the test

- 1) Test temperature & humidity: 55°C/95% RH;
- 2) Connect the MIC with the mobile phone, let them work for 168h in the chamber, and play 94DBSPL pink noise at 10mm away from the MIC.

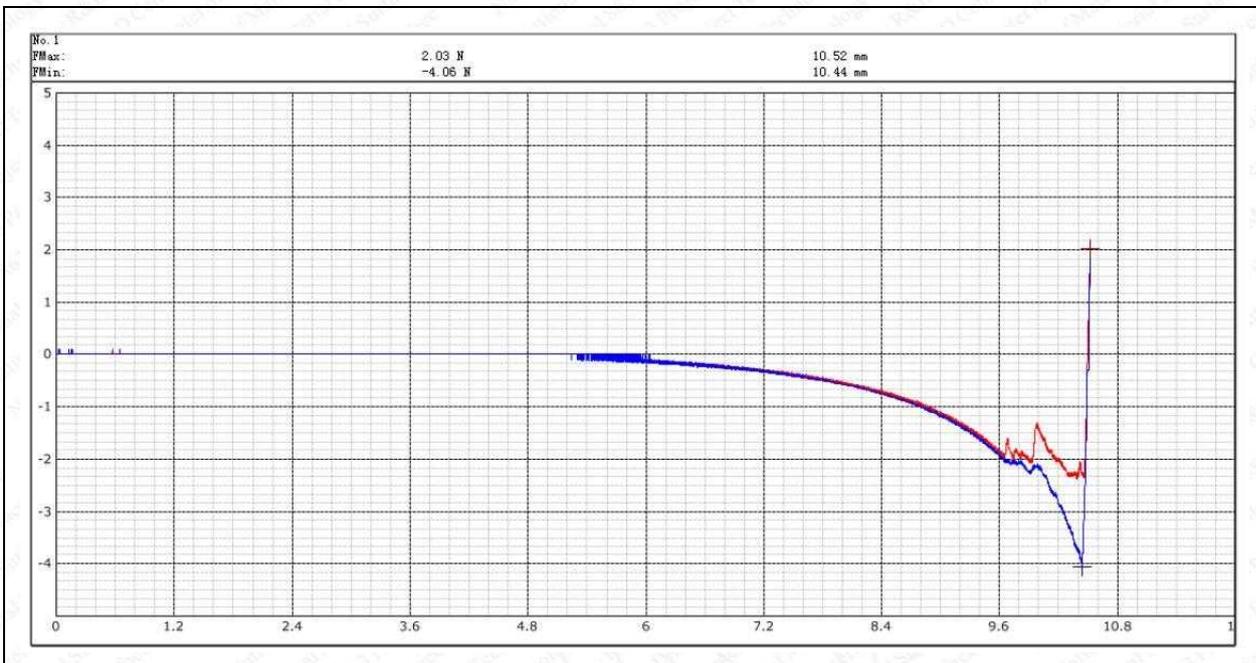
Fig.4 Pull-out force curve before the test

Note: Change rate= | The force after the test- The force before the test | ×100/ The force before the test

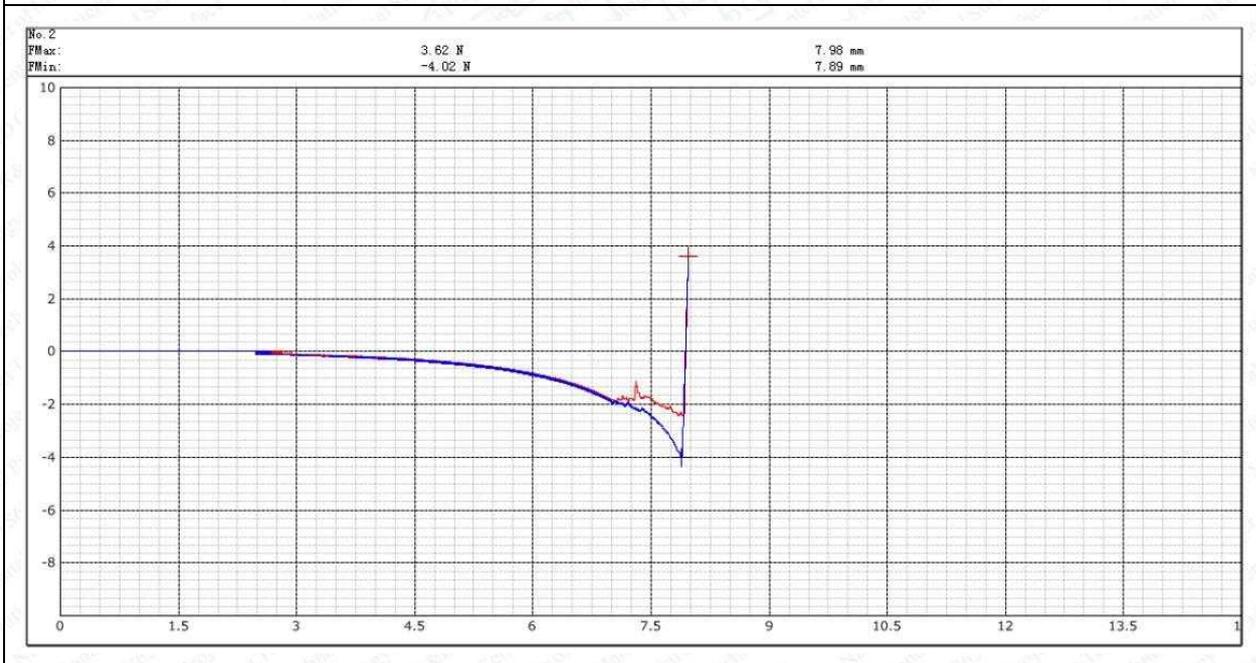
Fig.5 Pull-out force curve after the test

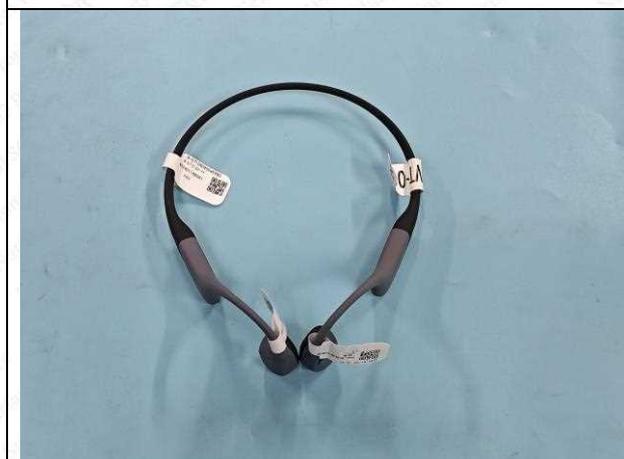
Fig.3 After test sample photos

Sample No.	Test Result(s)	Conclusion
8#	After the test, the sample function is normal. No defects such as tackless, device falling off/loosening, swelling, cracking, brittle breakage, silica gel cracking, etc can be visible on the sample.	PASS

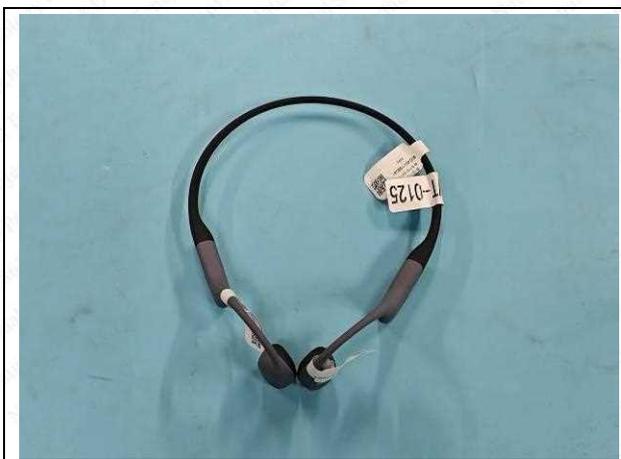
Fig.5 After test sample photos

Sample No.	Test Result(s)	Conclusion
5#	After the test, the function of the sample is normal, there are no defects such as tackless, bumping, rupture, device falling off/loosening, cracking, brittle breakage, silica gel cracking, etc can be visible on the sample.	PASS

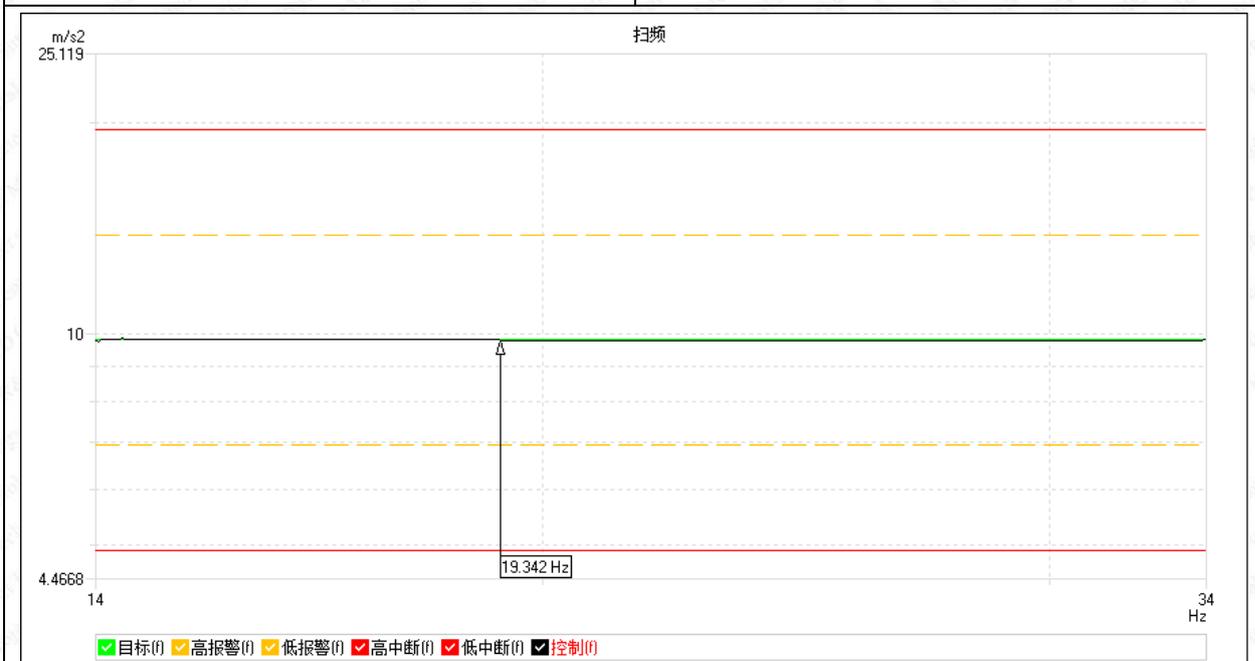
Fig.7 Test curve (X-axis)

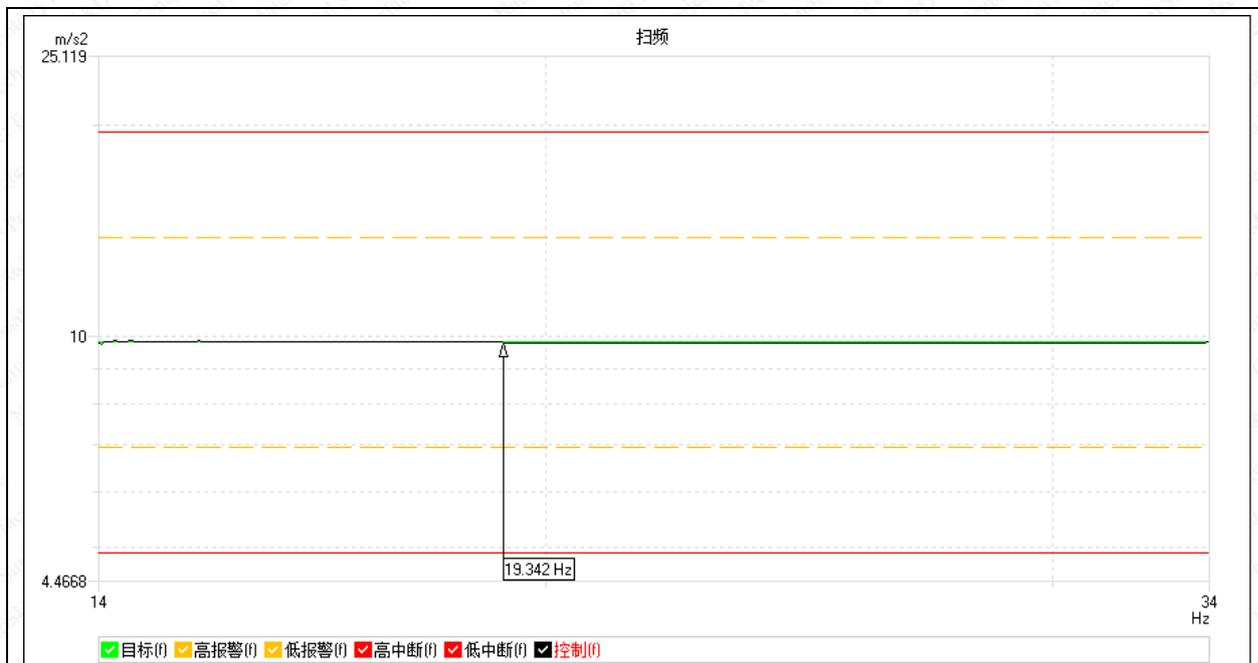
Fig.8 Test curve (Y-axis)

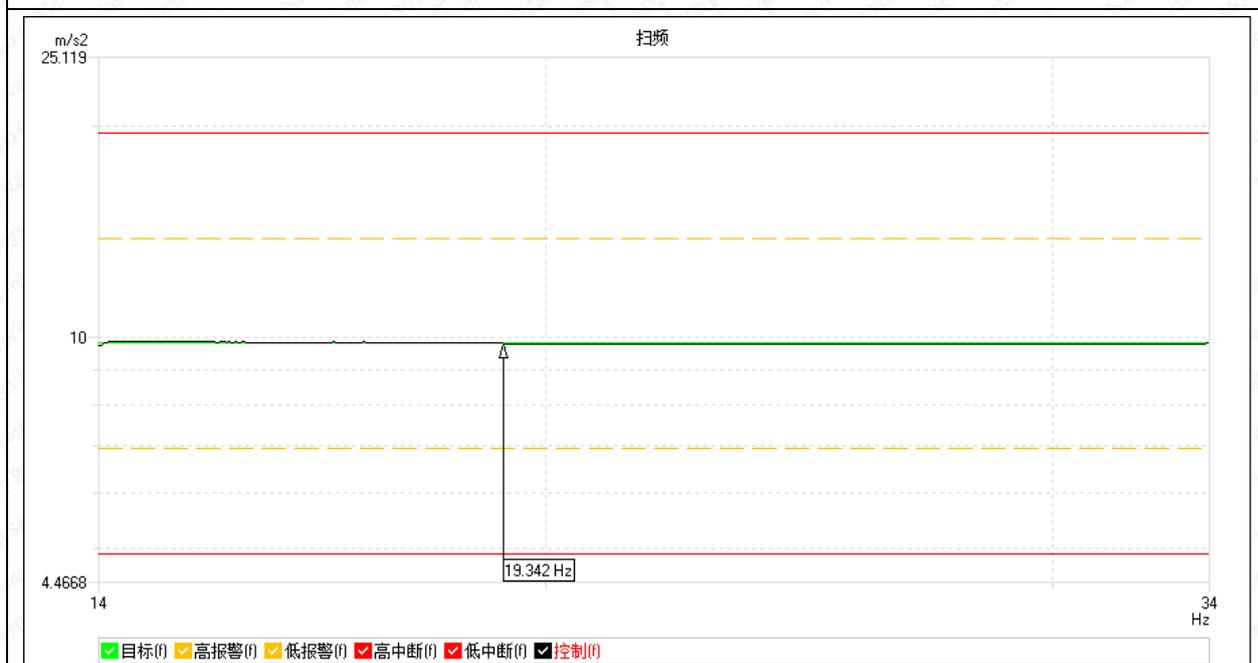
Fig.9 Test curve (Z-axis)

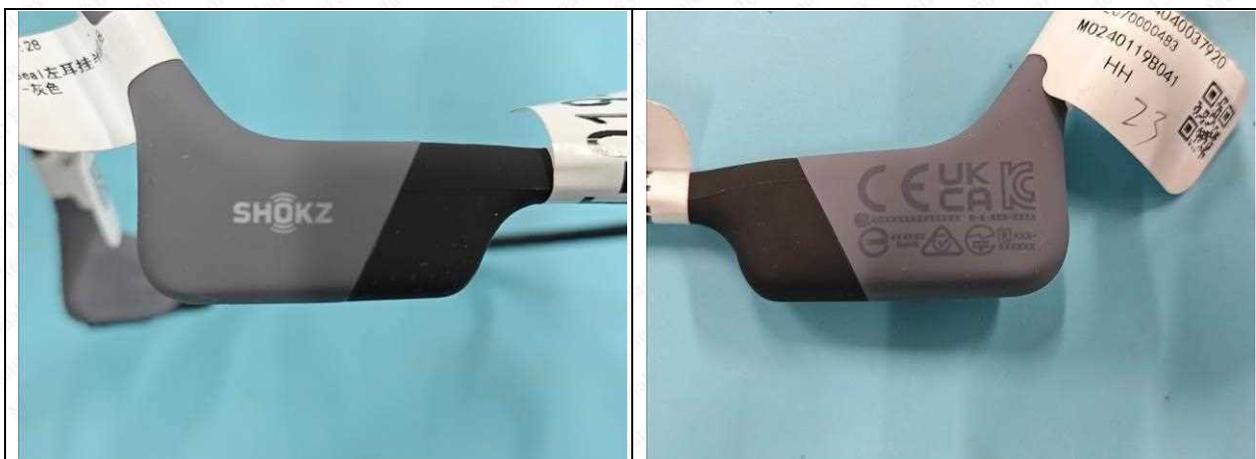
Fig.3 After test sample photos (Board screen printing position)

Sample No.	Test Result(s)	Conclusion
4#	After the test, no obvious fading or exposing the substrate on the coating surface, no wearing or fading on the printed /laser etching logo and the font contents are still complete, clear and recognizable on the tested areas.	PASS

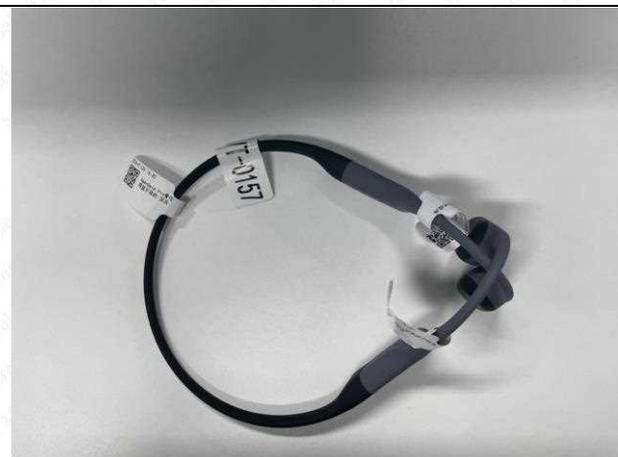
Fig.3 After test sample photos

Sample No.	Test Result(s)	Conclusion
11#	After the test, the mechanical properties of the sample have no obvious change, no titanium wire breakage, damage or other phenomena; Sample function is normal.	PASS
