Intel[®] Core[™] i7 Processor Family for LGA2011-v3 Socket

Specification Update

Supporting Desktop Intel[®] Core[™] i7-5960X Extreme Edition Processor Series for the LGA2011-v3 Socket

Supporting Desktop Intel[®] Core[™] i7-59xx and i7-58xx Processor Series for the LGA2011-v3 Socket

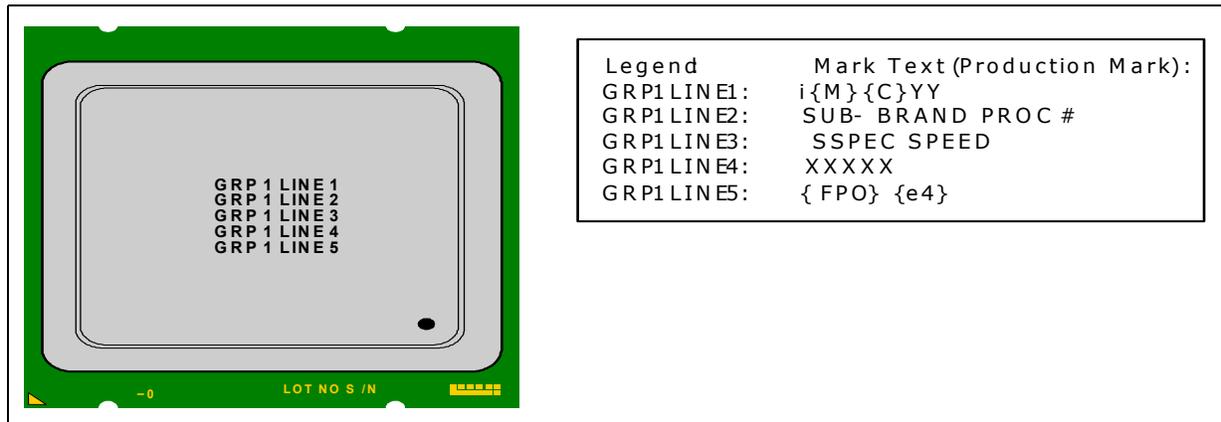
Figure 1. Processor Top-side Markings (example)

The processor stepping can be identified by the following component markings.
