# Macintosh Beep Codes

Explains a few beep codes for legacy Mac computers.

## Troubleshooting Master/Slave Problems with ATA hard drives

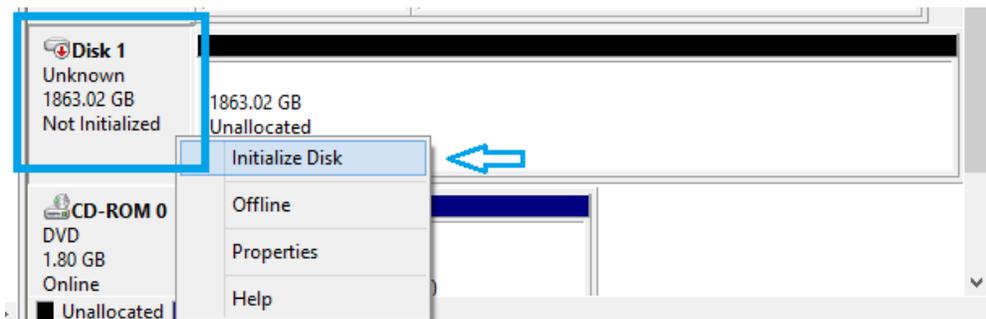
5. Right-click on the Disk that needs to be initialized.
6. From the menu select **Initialize Disk**.

**Note:** Windows will normally see the **uninitialized** drive when you open Disk Management and start the wizard to initialize the disk for you. In case the “Initialize Disk” wizard doesn’t start you may follow the instructions to manually initialize your disk:

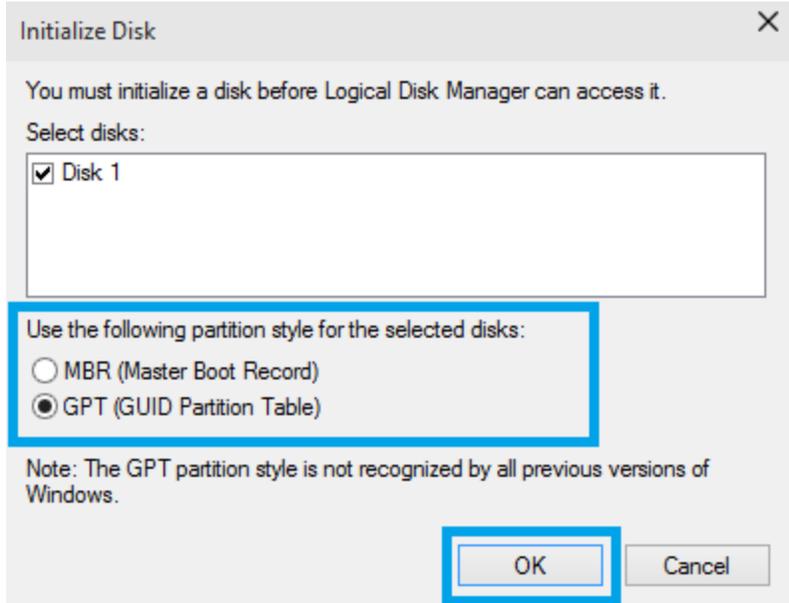
7. Select the appropriate **partition style**, MBR or GPT.

**Note:** The MBR Partitions can define a disk drive capacity up to 2.2TB. Windows operating systems that boot from an MBR are therefore limited to 2.2TB per MBR. The MBR Partitions can define a disk drive capacity up to 2.2TB. Windows operating systems that boot from an MBR are therefore limited to 2.2TB per MBR. GUID Partition Tables (GPT) can define drives larger than 2.2TB.

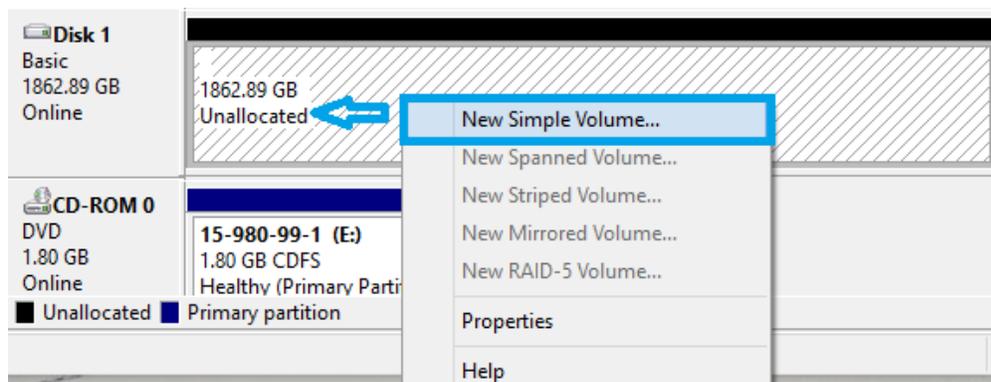
8. Once the disk is initialized, the partition will show **Unallocated**.
9. Right-click somewhere on the **Unallocated partition**.
10. From the menu select **New Simple Volume**.

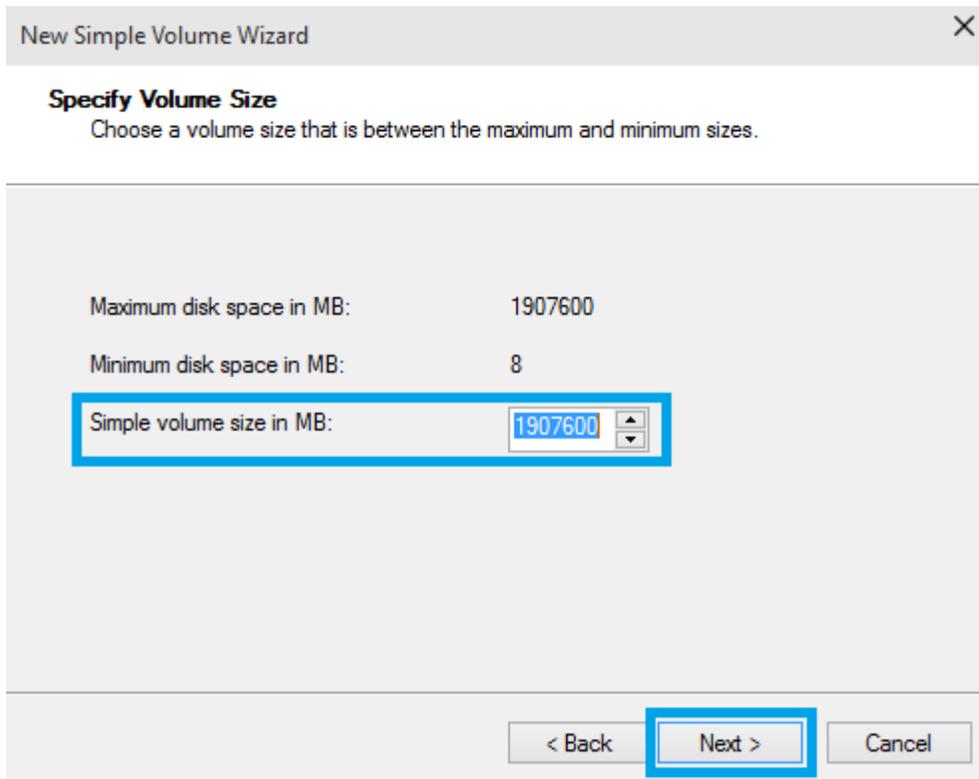
11. The New Simple Volume Wizard will prompt.
12. Click **Next**.
13. Specify **Partition size in MB** and click **Next**.

**Note:** If you want to create multiple partitions, change the **Simple volume size** in MB to the size of the partition you'd like to create.
