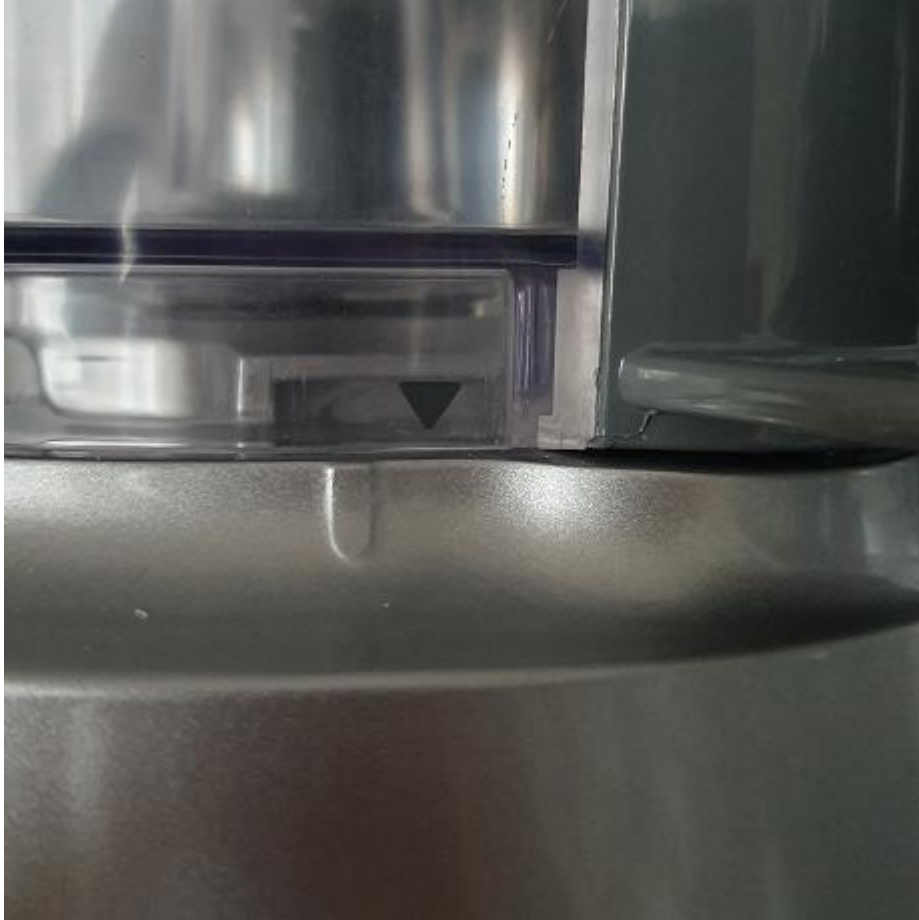
At this point, the bowl "feels" like it has locked fully into position, and the force required to push it further is quite high:

It happens because it is a particularly high quality locking position, which understandably customers sometimes do not feel confident in "forcing" the bowl past a friction point for fear of breaking it.

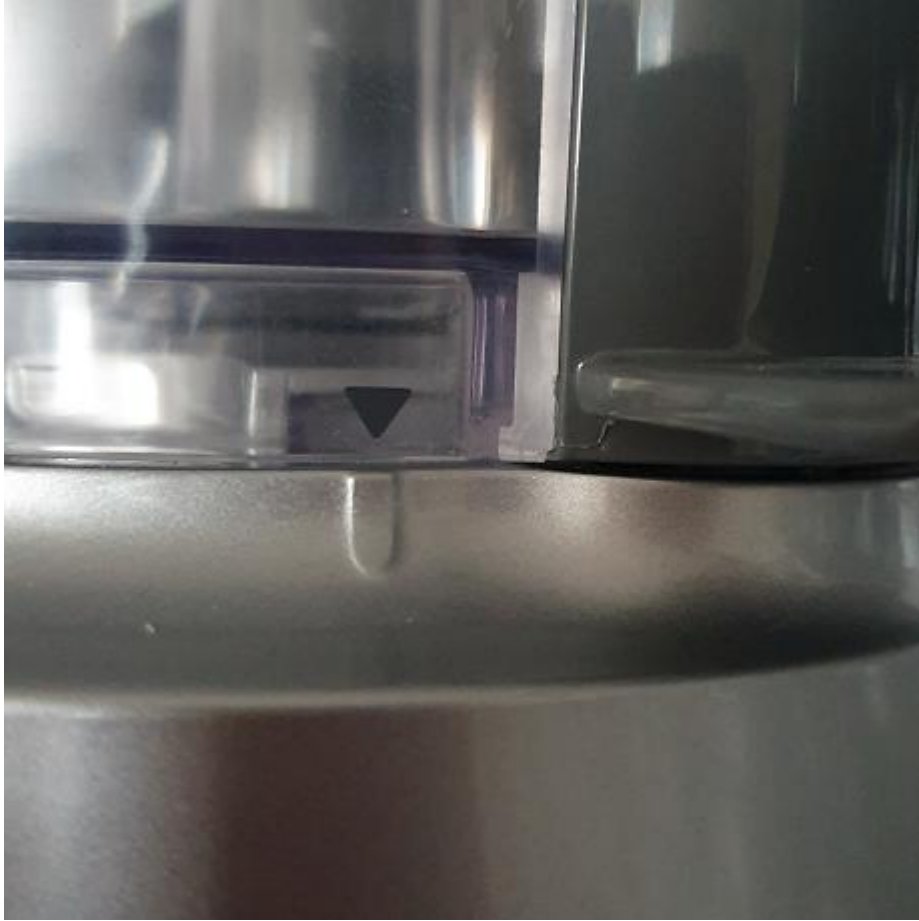
But the machine will still be interlocked and will not operate for safety reasons, so it must be pushed over the friction point to here:

This is the correct position and will allow operation.
