SAFETY INSTRUCTIONS

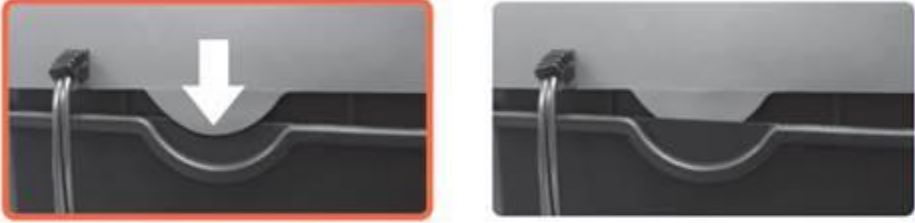
Properly seating the shredder unit

The diagram consists of two side-by-side photographs of a shredder's head unit being placed onto a wastebasket. The left photograph shows the head unit being pushed down into the wastebasket, with a white arrow pointing downwards. This is labeled 'Correct'. The right photograph shows the head unit resting on top of the wastebasket without being pushed down. This is labeled 'Not correct'.

Correct **Not correct**

Make sure the head unit portion of the shredder is correctly seated onto the included wastebasket with the printed words and icons facing you. The head unit is particularly designed to only work with the integrated wastebasket. Shredders are equipped with a safety interlock mechanism, which prevents the shredder from working when the head unit is lifted or removed, not correctly seated, or accidentally toppled over.

- Basket safety interlock switch is not activated. See below solution.

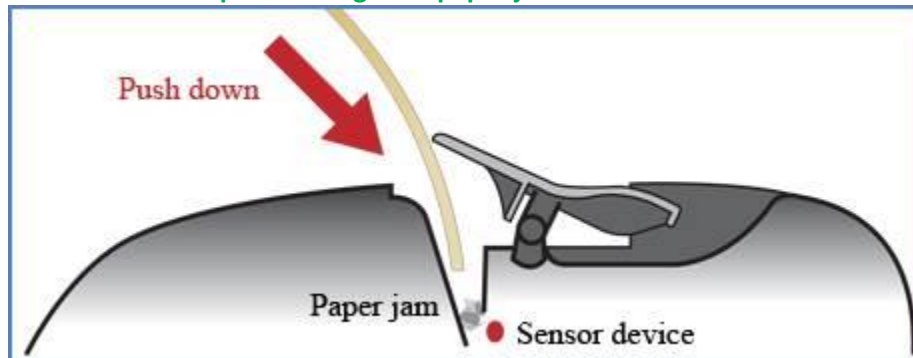
- Paper stuck inside of the feeding slot due to overfeeding or leaving the basket too full. **Solution: Feed a card stock or stiff index card to push through the paper jam while in AUTO mode.**
